Structural Inspection & Repair Estimate

Report No. 9020-R-001, Revision No. 0

1334 5th Avenue, LLC (Current building Owner)
1344 Fifth Avenue
Pittsburgh, PA 15219

Orbital Engineering Project No. PIT.23.9020

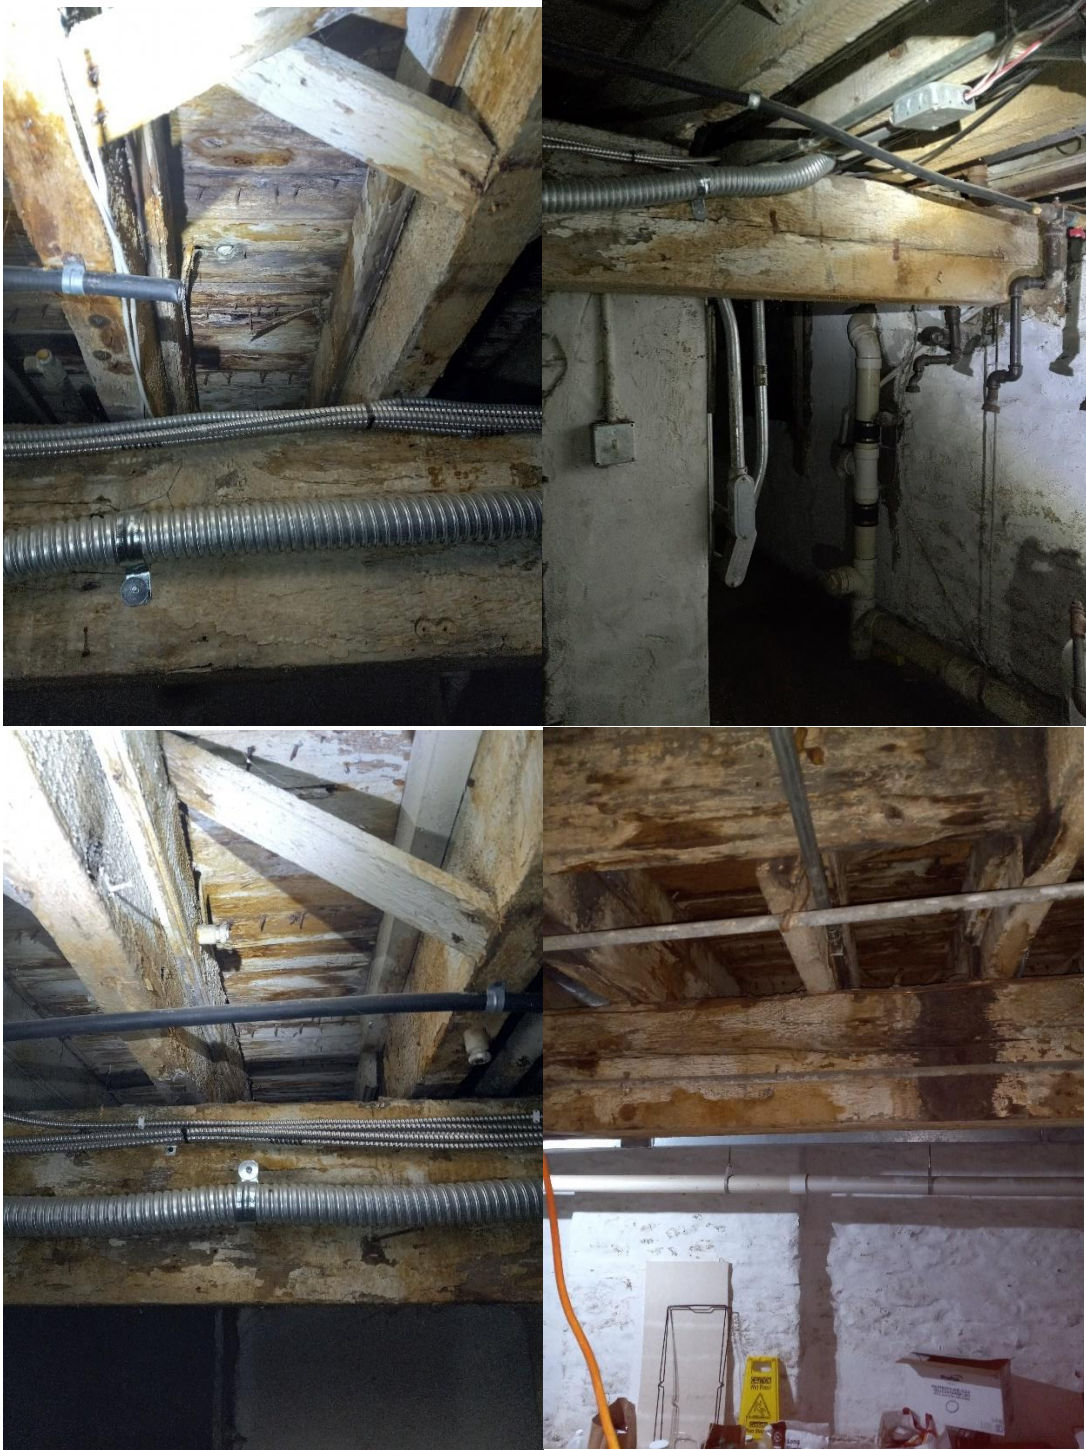
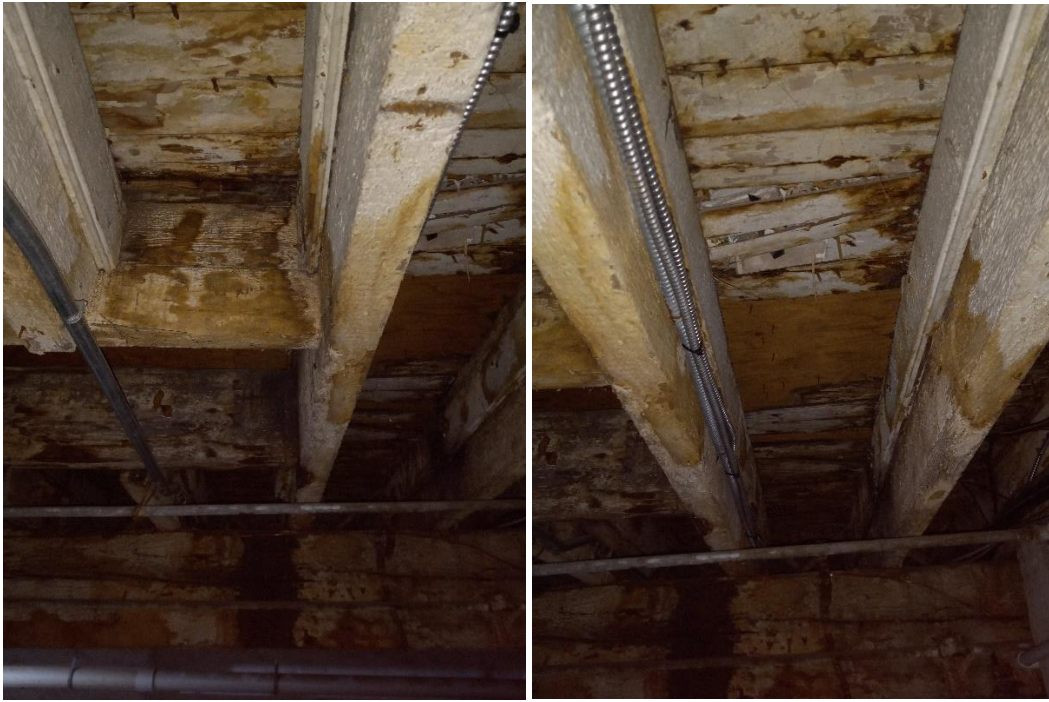
6.1 First-Floor Framing: The first-floor wood framing, as observed from the basement, is in poor condition and has deteriorated over time due to moisture penetrating and impacting the wood, use, and the lack of any preventive maintenance. There are large cracks in primary framing members and secondary members along with visible wood rot/deterioration along with multiple areas where the first-floor subfloor has failed and been repaired unprofessionally. Reference the pictures below outlining deficiencies that were observed during the inspection.

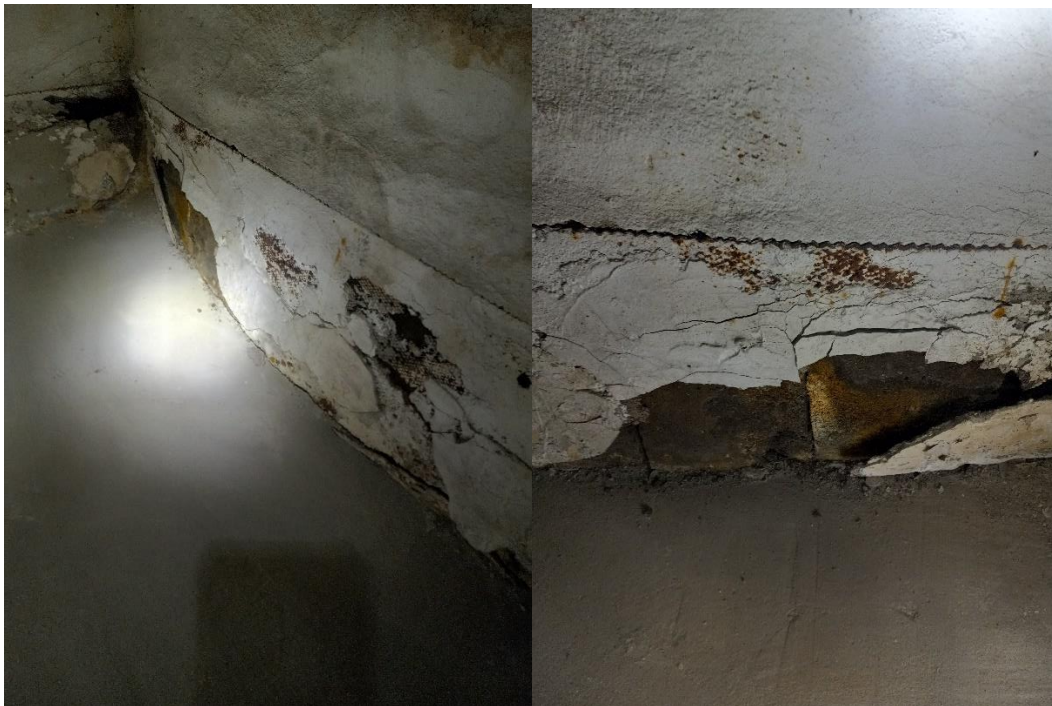
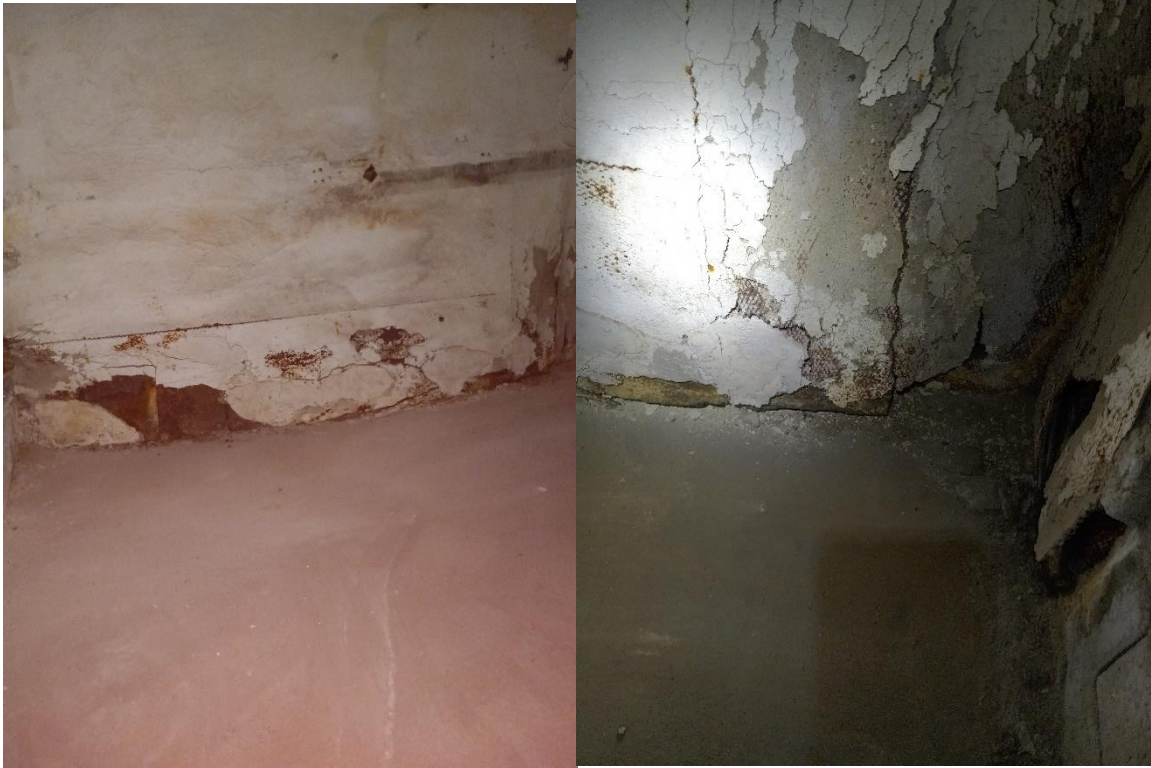
6.2 East Foundation Wall: the east foundation wall, approximately 20 feet down towards the alley from the building front, has failed. It was observed during the inspection that this wall at the base, close to the basement slab, has moved in towards the basement approximately three to four inches in a 5 foot linear area along the wall. Signs of moisture were observed in this area. Reference the pictures below showing this deficiency observed during the inspection.

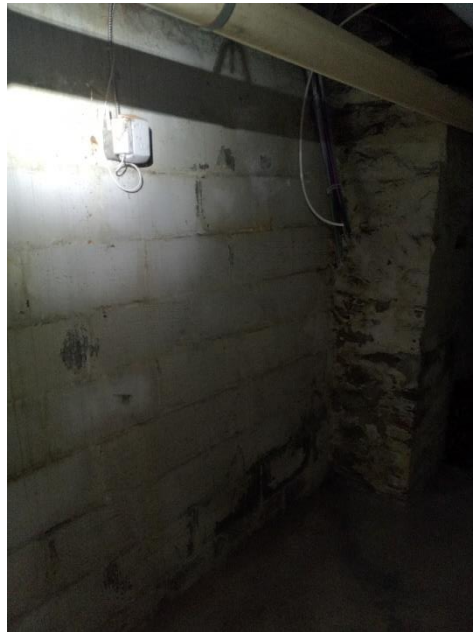
6.3 West Foundation Wall: it was observed during the inspection that the West foundation wall had been replaced with concrete blocks at some point. This should be noted since the replacement of the sandstone foundation with a new concrete block wall resulted from a deficiency that had to be mitigated. And if the root cause has not been addressed, this type of deficiency will continue in the foundation structure. Reference the picture below taken during the inspection.

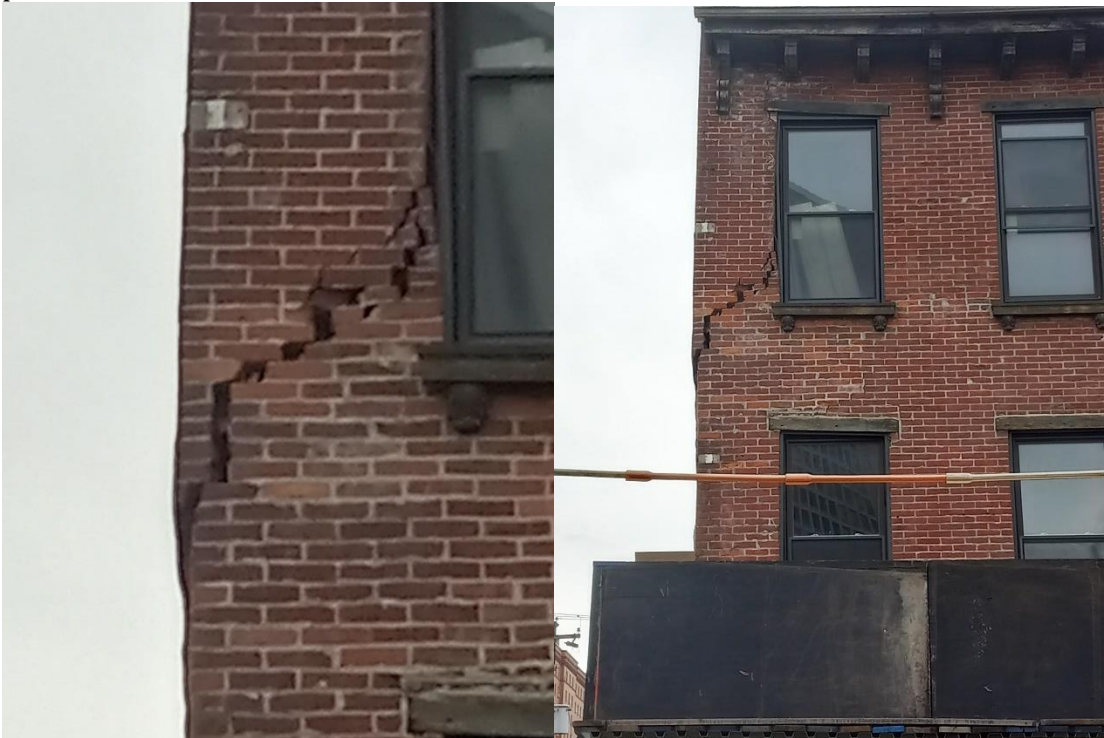
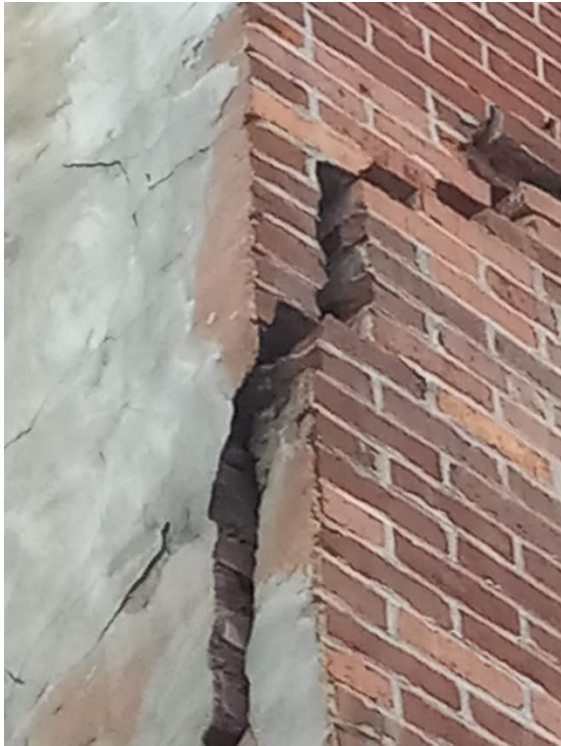
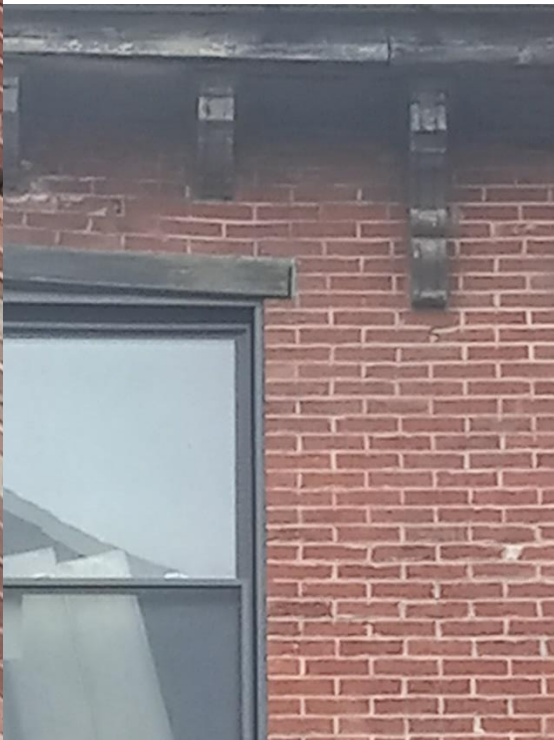
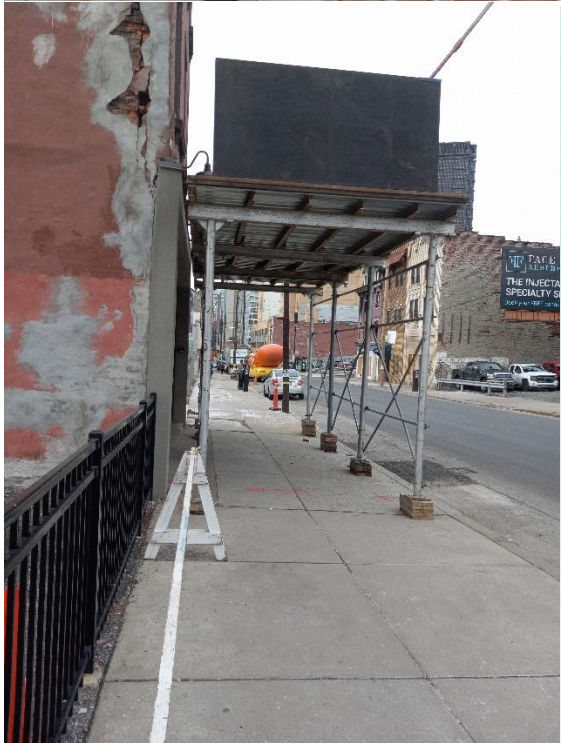
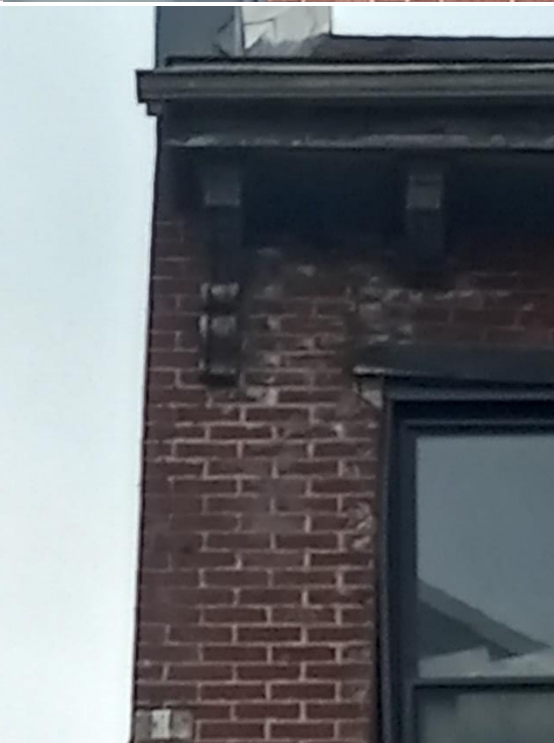
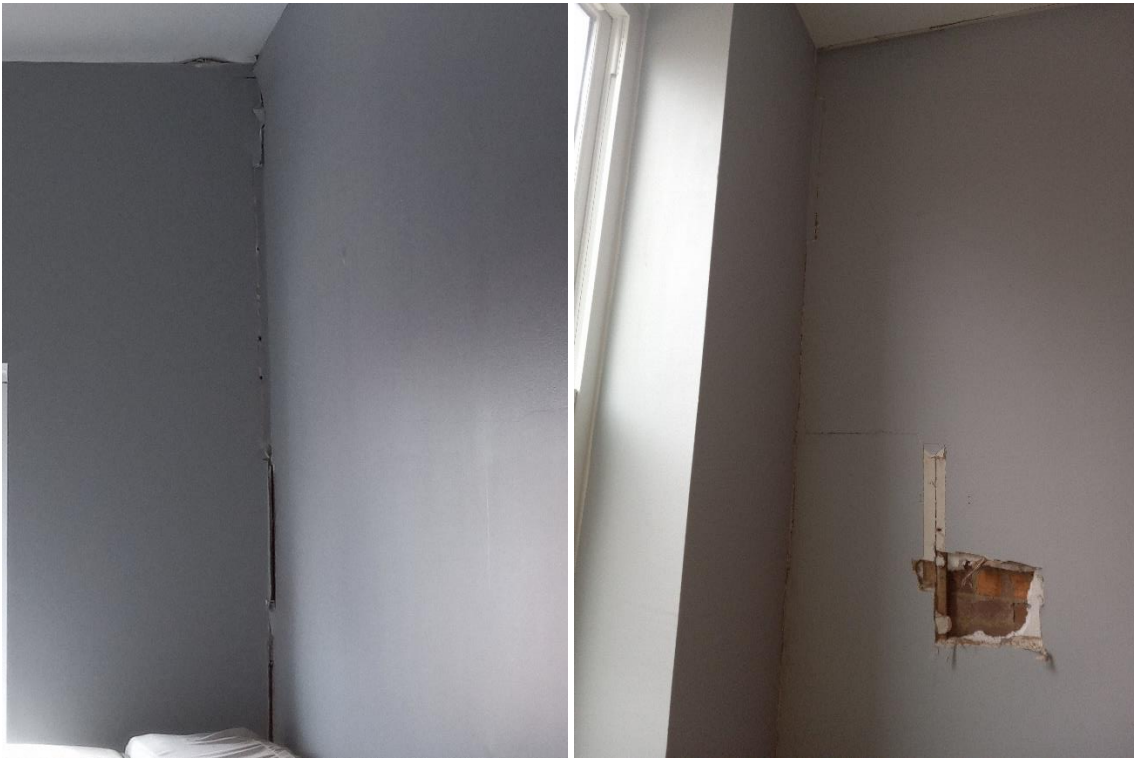
6.5 Front Facade: The building's front facade is a major concern not only from a structural evaluation but from a public safety perspective. As a result of poor preventive maintenance practices and allowing moisture to penetrate the structural brick walls, the facade has deteriorated such that the front door for the storefront will not close as a result of this movement. One major concern is that the whole front wall is observed to be moving away from the building structure towards 5th Ave. Thus a public safety concern such that the current building owner has installed protective scaffolding along the sidewalk. Windows on the second and third floors show signs of movement such that lintels on top of the windows supporting the brick above are no longer level. Brick and other materials associated with the wall are continually falling to the ground at this location. Reference the pictures below for these deficiencies.

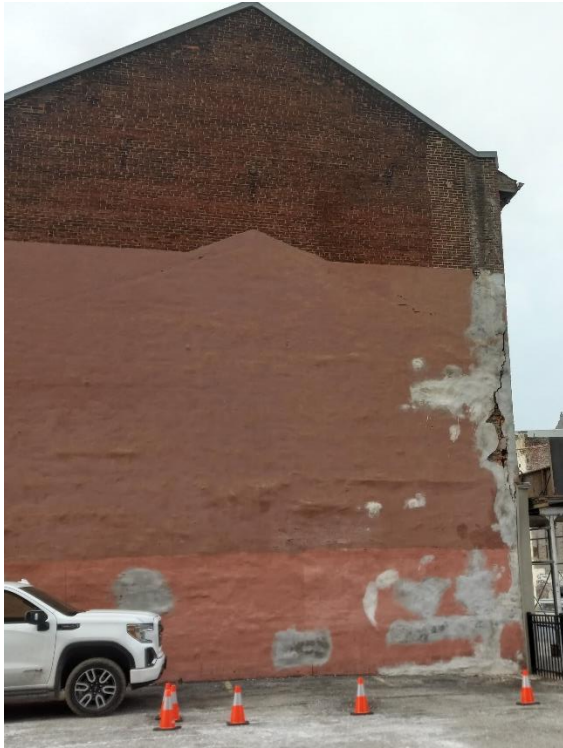
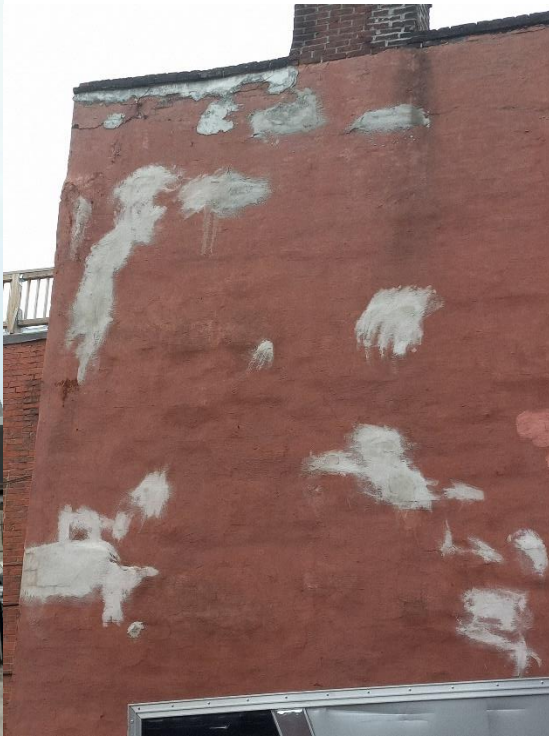
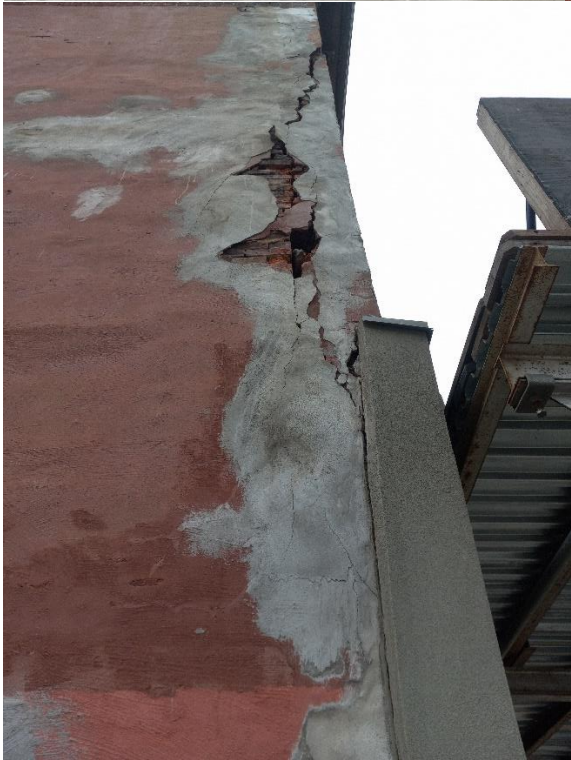
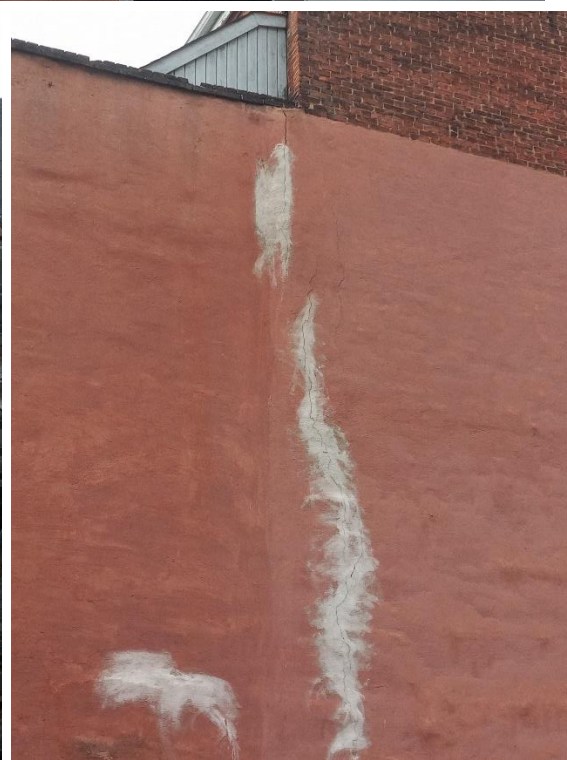
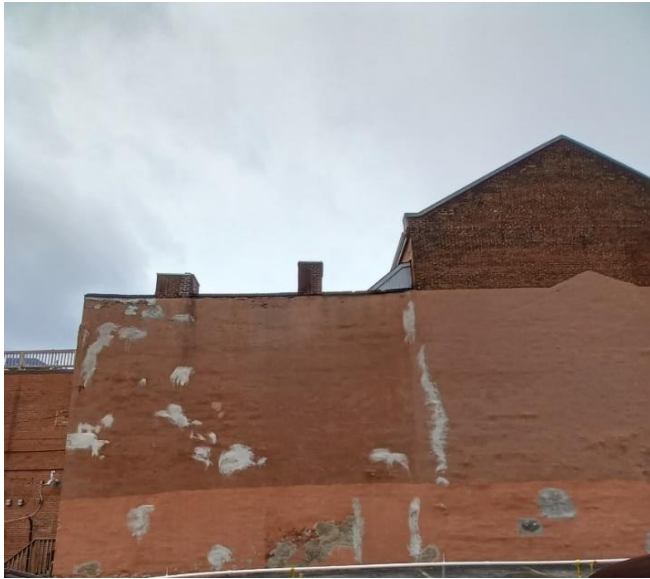
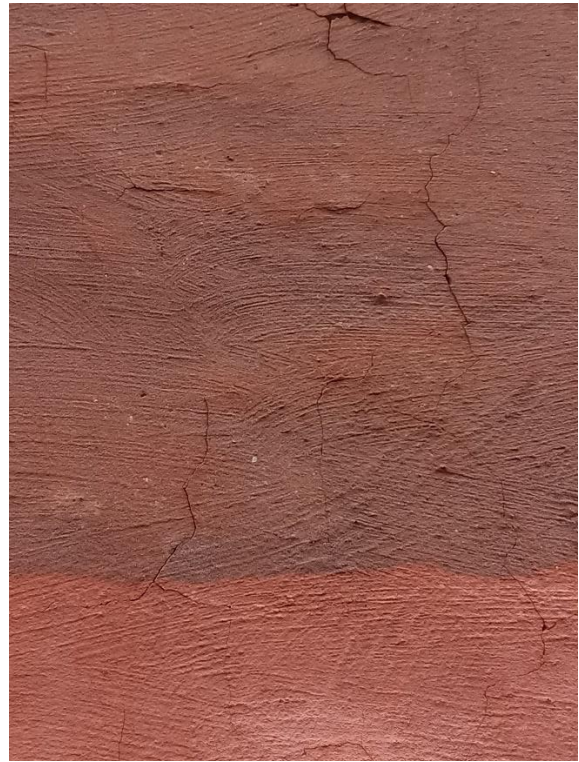
6.6 East Building Exterior: The building's east side, at some point, had a brick wall covered with stucco material. The stucco material was not installed professionally based on observations from the inspection to take into account the condition of the wall at the time of the application. As a result, over time, moisture has penetrated the stucco and, during freeze and thaw cycles, has deteriorated the wall such that material is falling to the ground and cracks are forming. Some patches have been applied to areas that have fallen away; however, since the root cause of the deficiency has not been addressed, this will continue throughout the life of the building. Reference the pictures below for observed deficiencies.

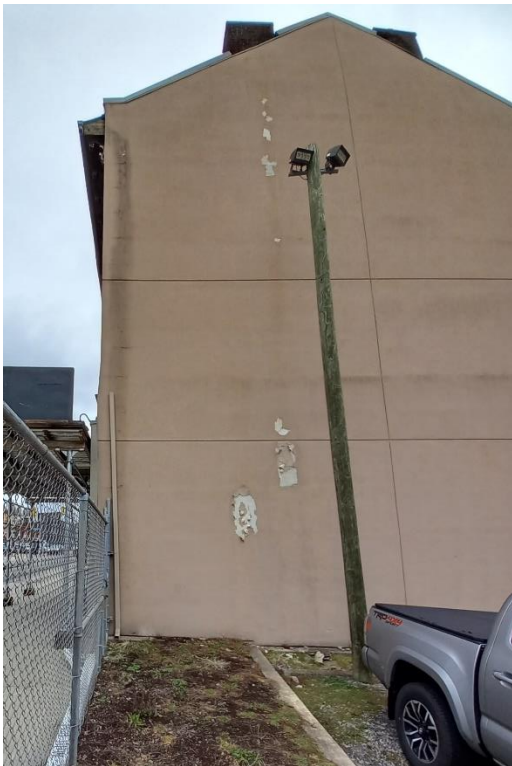
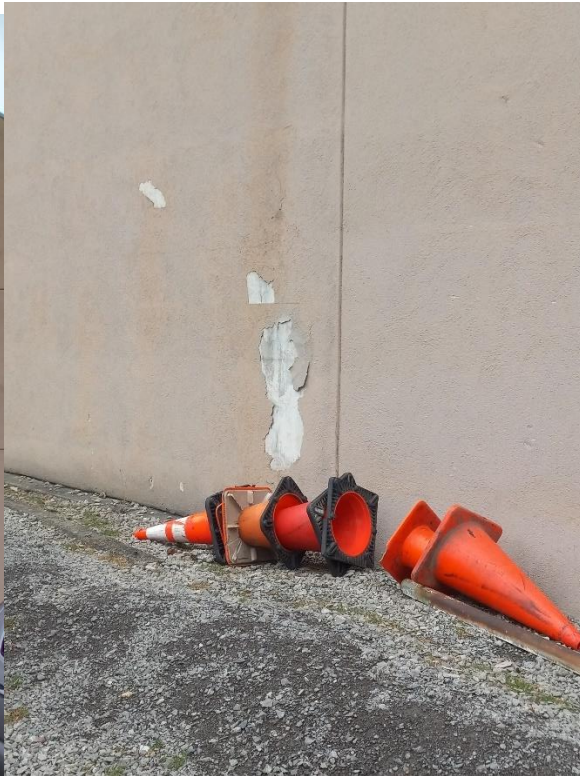
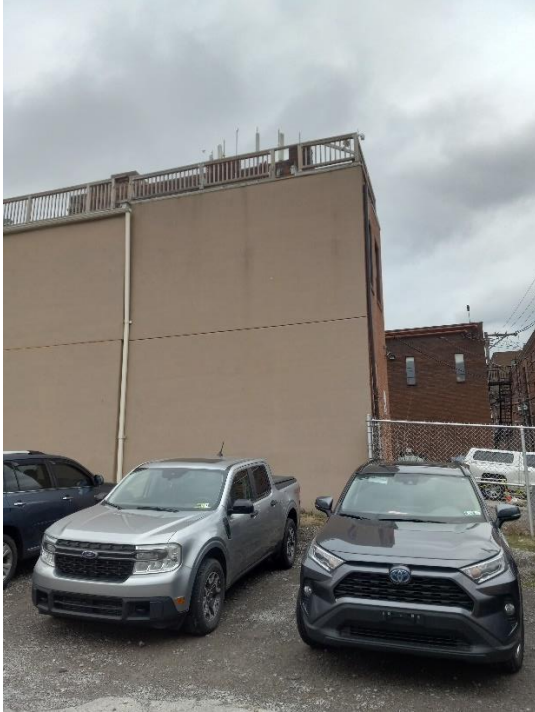
6.7 West Building Exterior: On the building's West side, at some point, a stucco covering was applied to it more recently than the east side. This wall appears to be in better shape than the exterior walls. However, there are signs of moisture running down the face as a result of poor downspouts or coping above, plus there are signs of moisture getting underneath the stucco, as shown where it has fallen off the side of the building. Reference the pictures below for these deficiencies.

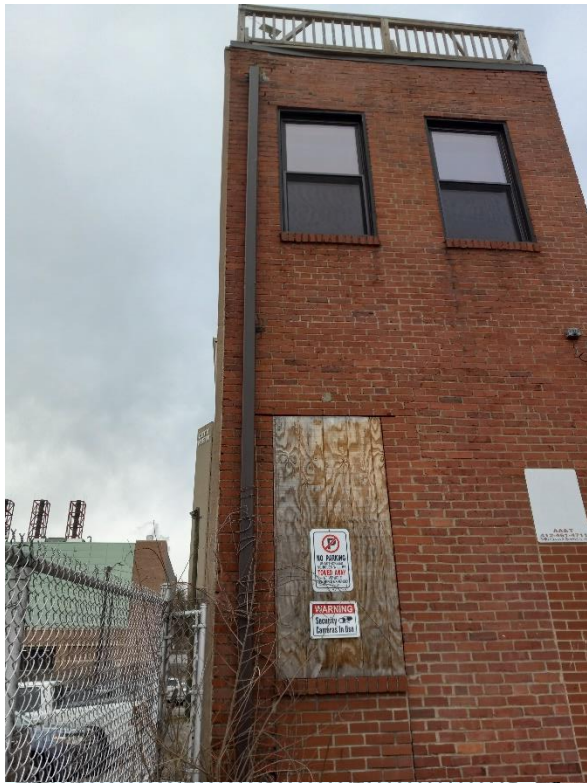
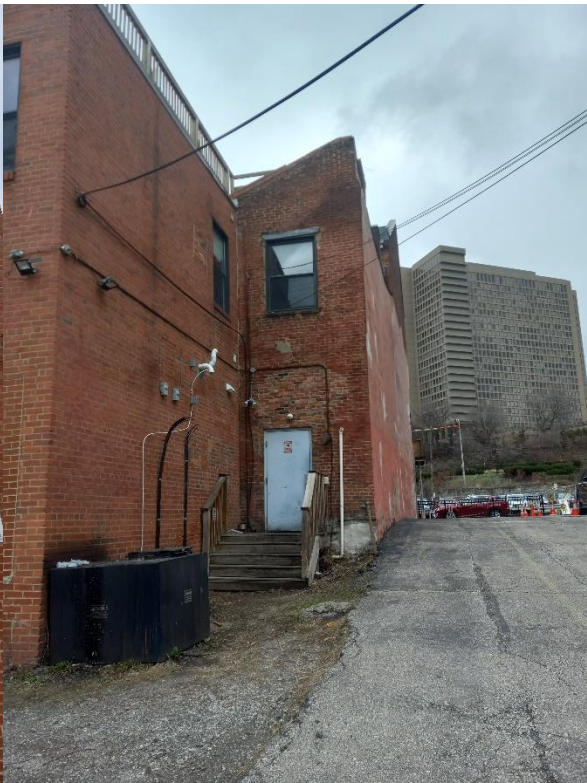
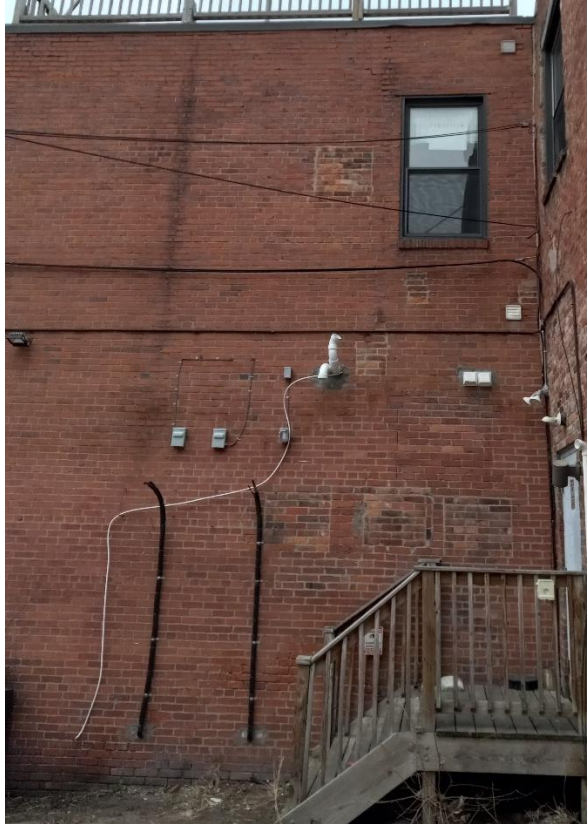
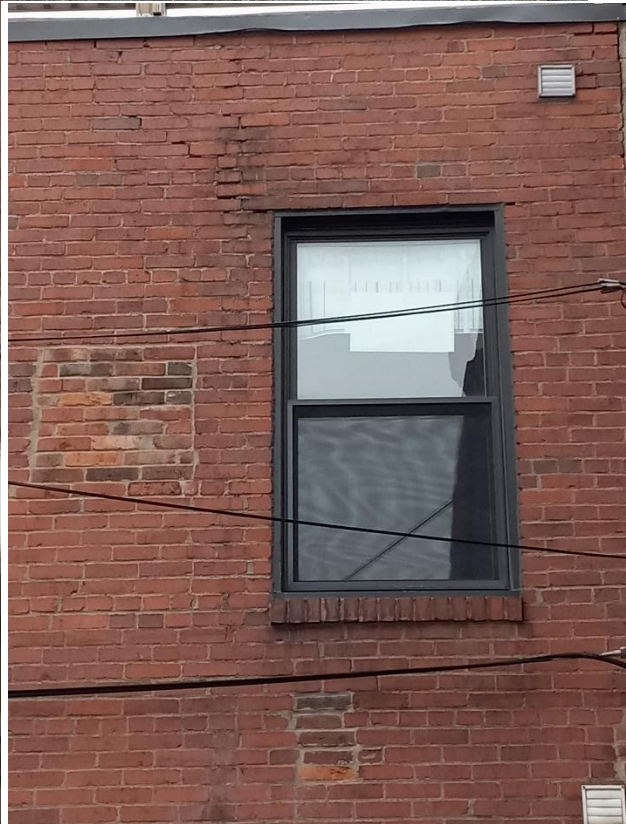
6.7 Rear Building Exterior: The rear building exterior has areas where the brick and grout interface has been cracked, thus allowing moisture to penetrate the wall and cause further deterioration. Reference the photos below showing these deficiencies.

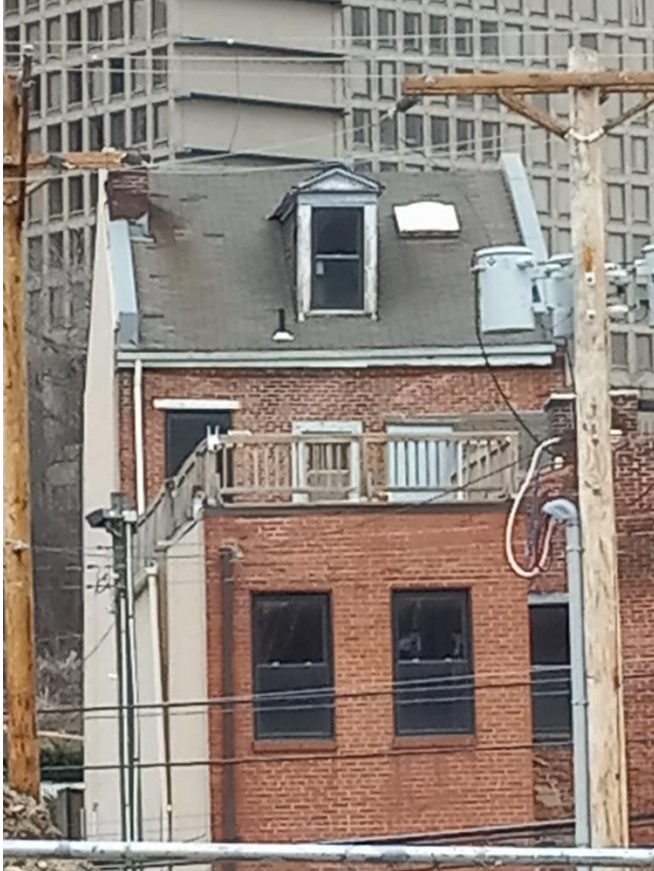
6.8 General Deficiencies: each floor was observed to have areas that were not level or uneven. Based on the observations of the inspection, it would be assumed that these were either installed this way, which is doubtful, or there has been deformation throughout the life of the building that would cause this movement, either framing deficiencies or settlement and movement in the exterior and foundation wall system. The flat roof in the rear of the building is in fair shape, but the top of the parapet is in poor shape and requires work to ensure moisture does not continue to penetrate the brick wall. The pitch roof shingles were observed to be in poor shape, with some missing areas along with the interface of the dormers to the roof needing to be sealed up better to ensure a watertight connection.
